Published in:
Coatings

High Friction Surfacing Systems Using Blends of Natural Aggregate and Calcined Bauxite

Shaun Friel ¹ and David Woodward ^{2,*}

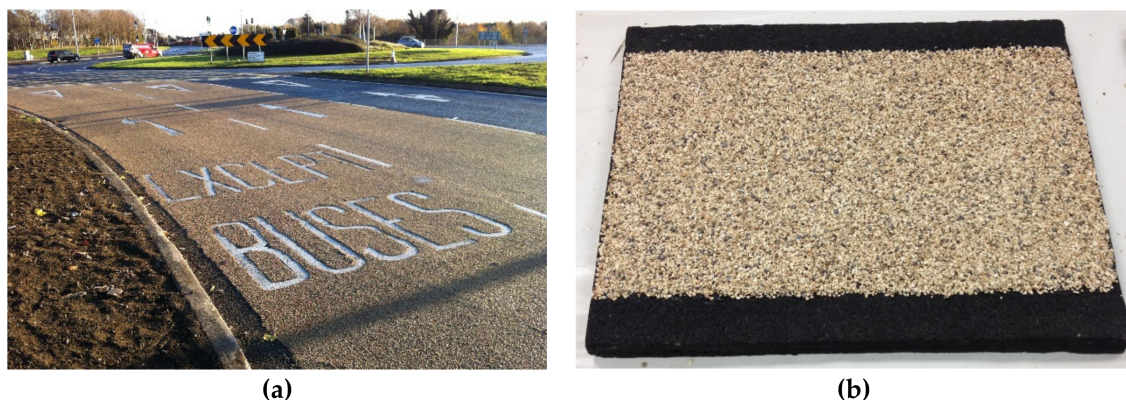
Figure 1. (a) Newly laid HFS system in Ireland; (b) cold applied HFS specimen used in Experiment 1.

The two components (A and B) of the epoxy system were thoroughly mixed at a ratio of 50:50 until homogenous. The epoxy binder was then spread evenly over the test plates/slabs using a serrated edged squeegee at a coverage rate of 1.8 kg/m². Aggregates of various blend ratios were then spread over each test plate/slab to excess. After initial curing over-night the excess was removed by brushing. The specimens were then left to fully cure. Figure 1a shows a newly laid HFS system on an approach to a roundabout in Ireland whilst Figure 1b shows a cold applied HFS specimen prior to simulated traffic testing in Experiment 1.

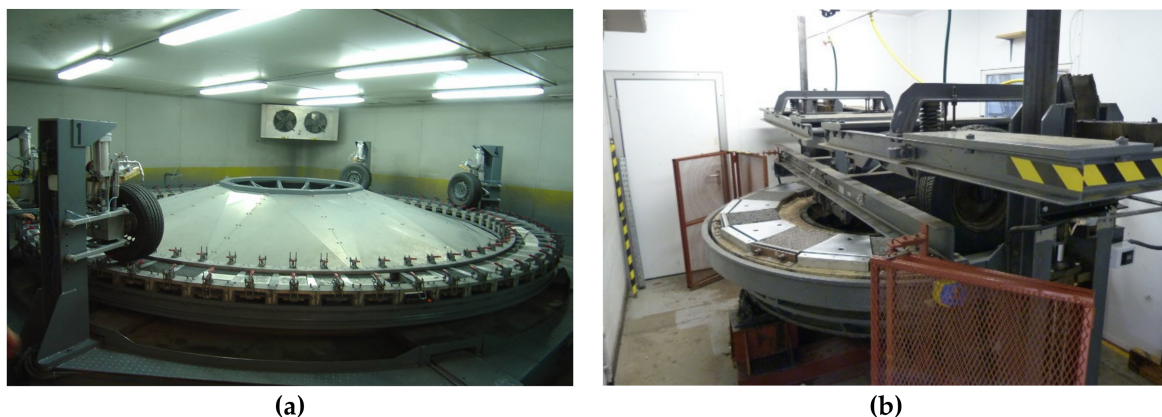
Figure 2. (a) The wear simulator turntable located at Aetec Laboratories, Madrid; (b) the road test machine located at Ulster University.

The wear simulator turntable located at Aetec Laboratories is primarily used to assess the performance of road marking materials [20]. The Turntable consists of a 6.4 m external diameter table that can rotate up to a maximum speed of 120 km/h. Up to eighteen test plate specimens can be mounted on the table. Four vertically mounted approved commercial tires with pressures of 0.25 ± 0.02 MPa run freely on the table at a steering angle of $1^\circ \pm 10'$, applying a load of 3000 ± 300 N on the test specimens from each tire.

The wear simulator has a water dispenser to apply water over the test plates and a cleaning system to keep the specimens and tires clean. The turntable is enclosed in a temperature-controlled room where testing is carried out at 7.5 ± 2.5 °C. The agreed test intervals were: 0 wheel-passes (WP), 5000 WP, 40,000 WP, 100,000 WP, 200,000 WP, 500,000 WP, 1 million WP, and 1.5 million WP. For the first 500,000 WP a steering angle of $1^\circ \pm 10'$ was used with the remainder of testing carried out at a steering angle of $1.5^\circ \pm 10'$. For every hour of simulated trafficking on the turntable the following test conditions were maintained: 15 min of wet trafficking at 15 km/h followed by 45 min of dry trafficking at 60 km/h. The wear simulator Turntable is shown in Figure 2a.

The RTM equipment consists of a 2.1 m diameter table that rotates at 10 RPM or 1.1 m/s. The table has spaces for mounting ten 305 mm × 305 mm × 50 mm test specimens. These are typically asphalt slabs made using a roller compactor unto which the HFS is applied. Two vertically mounted full size 195/70R14 tires run freely on the table each applying a load of approximately 5 kN. Tire inflation pressure is maintained at 2 bar or 30 psi. During testing the tires track back and forth across the width of the test specimen generating additional stress. The RTM is enclosed in a temperature-controlled

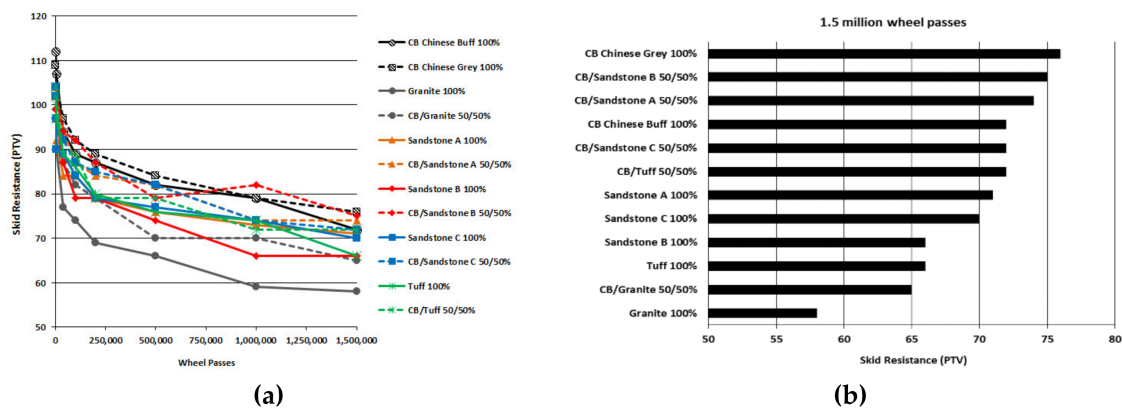
Figure 3. (a) Skid resistance development up to 1.5 million wheel-passes; (b) skid resistance ranking after 1.5 million wheel-passes (Aetec data).

Table 2 and Figure 3a show the development of skid resistance for the slab specimens up to 1.5 million wheel-passes. There is a ranking of specimens before, during and after testing on the wear simulator turntable. All the test specimens followed a similar downward trend of development during simulated trafficking. Skid resistance values were initially very high for all specimens prior to trafficking, followed by a decline in skid resistance to equilibrium levels.

Figure 3b shows the skid resistance data for the specimens ranked in order of performance after 1.5 million wheel-passes of simulated trafficking. After 1.5 million wheel-passes the specimens had undergone considerable polishing and as would be expected, the specimen containing 100% granite performed the worst. The second worst performer was the specimen containing a blend of 50% granite and 50% calcined bauxite (CB) Chinese grey. Even though 50% of the granite was replaced with 50% of the overall best performing aggregate (CB Chinese grey) it was still the second worst performer. This shows the susceptibility of granite to polishing by vehicle tires over time.

Figure 3b shows that half of the worst performing specimens were made using 100% natural aggregate and one other specimen which contained 50% granite. Half of the best performing specimens contained either 100% calcined bauxite or a blend of sandstone or tuff and calcined bauxite. Two of the specimens containing a blend of sandstone and calcined bauxite out-performed the specimen containing 100% Chinese buff calcined bauxite. This shows how blending calcined bauxite with high PSV sandstone or tuff can increase wet skid resistance.

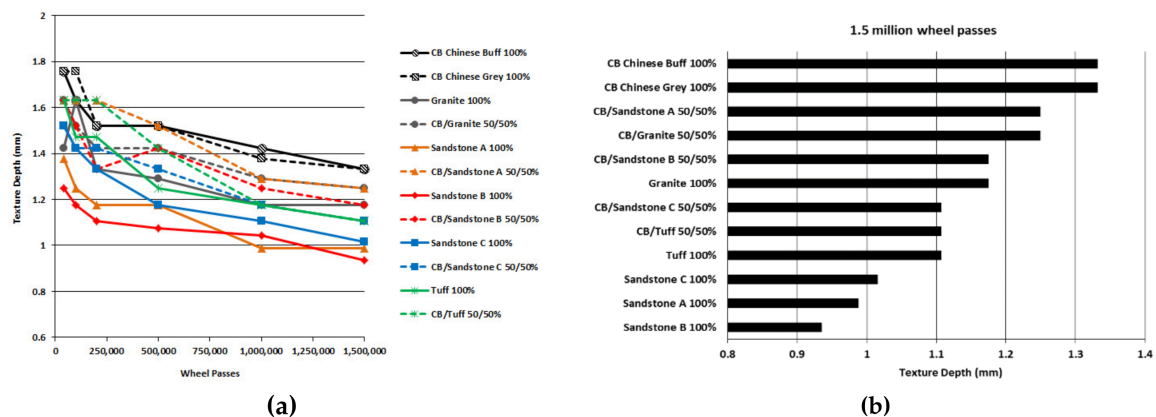
Figure 4. (a) Texture depth development up to 1.5 million wheel-passes; (b) Texture depth ranking after 1.5 million wheel-passes (Aetec data).

Table 3 and Figure 4a show the development of texture depth for the slab specimens up to 1.5 million wheel-passes. Similar to the skid resistance data, there was a ranking of specimens before, during and after testing on the wear simulator turntable. All the test specimens followed a similar downward trend of development during simulated trafficking. Texture depth testing was not carried out prior to simulated trafficking due to the risk of the test sand affecting initial skid resistance values. Texture depth values were initially high for all specimens prior to trafficking, followed by a decline in texture depth levels.

Figure 4b shows the texture depth data for the specimens ranked in order of performance after 1.5 million wheel-passes of simulated trafficking. The best performers were the two specimens containing 100% calcined bauxite. The three worst performers were the specimens containing 100% sandstone. The graph shows that, blending calcined bauxite with natural aggregates can increase texture depth performance during simulated trafficking.

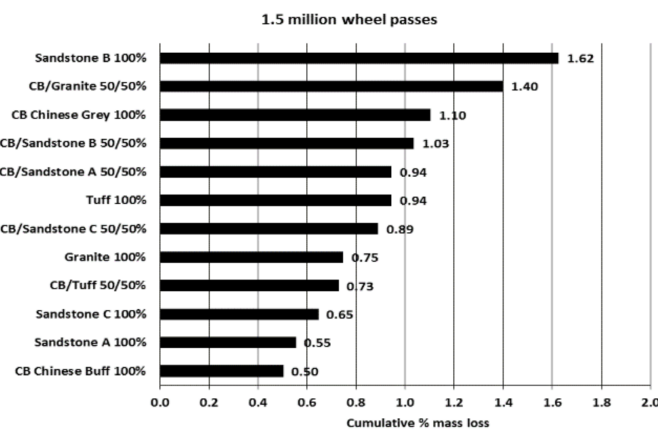
Figure 5. Percentage mass loss ranking after 1.5 million wheel-passes (Aetec data).

Very little aggregate loss occurred for the majority of specimens after 1.5 million wheel-passes. Figure 5 shows the cumulative percentage mass loss for each specimen after 1.5 million wheel-passes. This shows the specimens ranked in order of highest percentage mass loss (top) to lowest percentage mass loss (bottom).

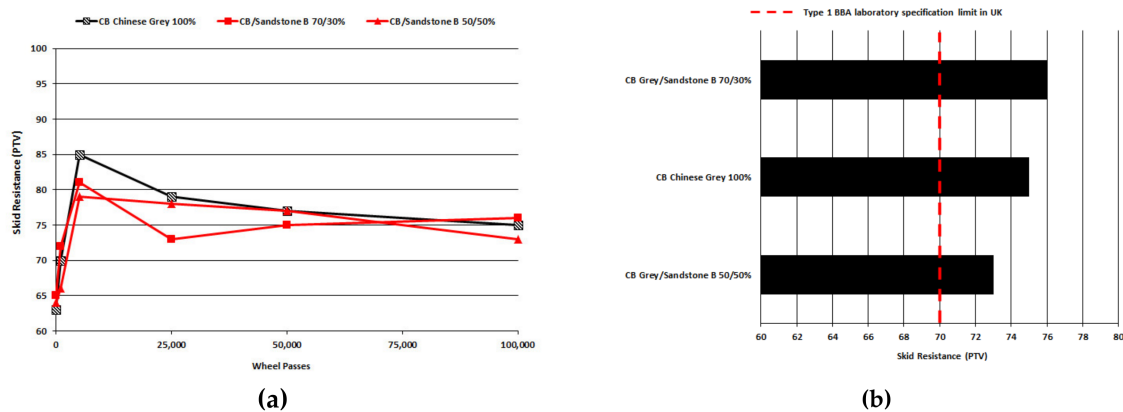
Figure 6. (a) Skid resistance development up to 100,000 wheel-passes; (b) Skid resistance ranking after 100,000 wheel-passes (Ulster University data).

Table 4 shows the development of skid resistance data for all the slab specimens up to 100,000 wheel-passes. Figure 6a plots the data for the specimens made using Chinese grey calcined bauxite and sandstone B up to 100,000 wheel-passes. Skid resistance values prior to simulated trafficking ranged from 63 to 65 before increasing significantly to a range of 79 to 85 at 5000 wheel-passes. This was caused by the excess aggregate on the surface of the test specimen influencing the initial pendulum testing. This was quickly worn off exposing the aggregate held by the resin binder. After 5000 wheel-passes the specimens began to polish and as a result skid resistance values began to decline. After 25,000 wheel-passes the CB/sandstone B 70/30% specimen increased in skid resistance for the remainder of testing. After 100,000 wheel-passes the two blended specimens were comparable to the Chinese grey calcined bauxite.

Figure 6b plots the data for the specimens after 100,000 wheel-passes of simulated trafficking. Included is a dotted line running vertically at 70 PTV. This is the BBA specification limit in the UK for Type 1 laboratory specimens tested after 100,000 wheel-passes in the RTM. This shows that all the specimens in this experiment would pass the BBA test requirements for Type 1 skid resistance after 100,000 wheel-passes.

In Experiment 2, Figure 6b shows that the specimen containing 70% Chinese grey calcined bauxite and 30% sandstone B outperformed the 100% calcined bauxite specimen by one point. The specimen containing 50% calcined bauxite and 50% sandstone B had a skid resistance of 73. Figure 7b shows the specimens ranked in order as would be expected. The 100% Chinese buff calcined bauxite specimen was the best performer with a skid resistance of 79. This was followed by the specimens containing 70% and 50% Chinese buff calcined bauxite with skid resistance values of 74 and 72 respectively. The early life friction development differs for both sets of specimens in Figures 6a and 7a. Figure 6a shows friction development increasing from 0 to 5000 wheel-passes before entering a downward cyclical trend of friction development. Figure 7a shows friction development decreasing in a downward cyclical trend throughout testing. Figures 8a and 9a shows both sets of specimens having similar trends of texture development. Both sets of data show that texture depth development stabilized after 25,000 wheel-passes and underwent minimal texture change for the remainder of testing. Figures 8b and 9b show that after 100,000 wheel-passes texture depths ranged from 1.9 to 1.6 mm. Both specimens containing 100% calcined bauxite had the highest texture depths. The experiment shows that all specimens would meet the laboratory wear test specification requirements for Type 1 HFS in the UK.

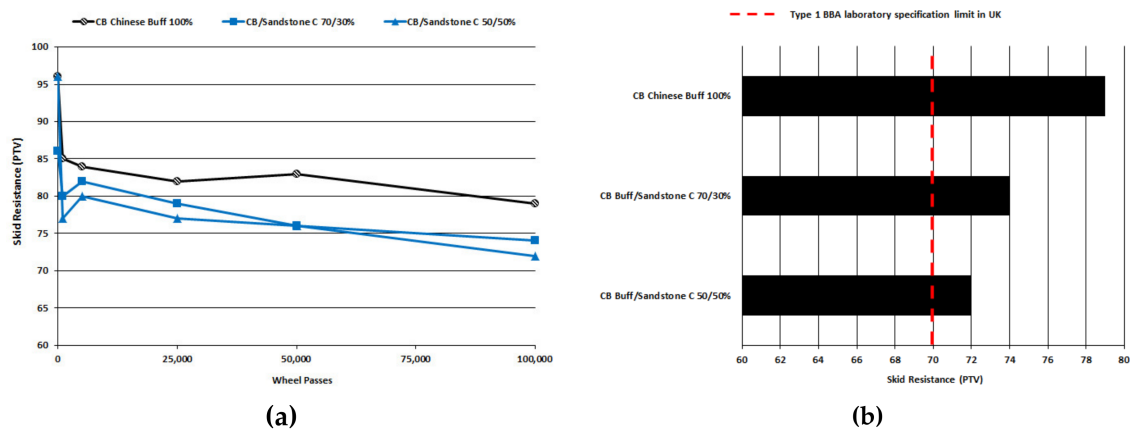
Figure 7. (a) Skid resistance development up to 100,000 wheel-passes; (b) skid resistance ranking after 100,000 wheel-passes (Ulster University data).

Figure 7a plots the data for the specimens made using Chinese buff calcined bauxite and sandstone C up to 100,000 wheel-passes. Skid resistance values prior to simulated trafficking ranged from 86 to 96 before declining up to 1000 wheel-passes. After 1000 wheel-passes the two specimens containing blends of calcined bauxite and sandstone C increased in skid resistance up to 5000 wheel-passes before entering a downward trend for the remainder of simulated trafficking.

Figure 7b plots the data for the specimens after 100,000 wheel-passes of simulated trafficking. The specimen containing 100% Chinese buff calcined bauxite was the best performer with a PTV of 79. The next best performer was the specimen containing a blend of 70% calcined bauxite and 30% sandstone and the worst performer was the specimen containing a blend of 50% calcined bauxite and 50% sandstone B. Included in Figure 7b is the BBA specification limit in the UK for Type 1 laboratory specimens tested after 100,000 wheel-passes. This shows that all the specimens would pass the BBA test requirements for Type 1 skid resistance after 100,000 wheel-passes.

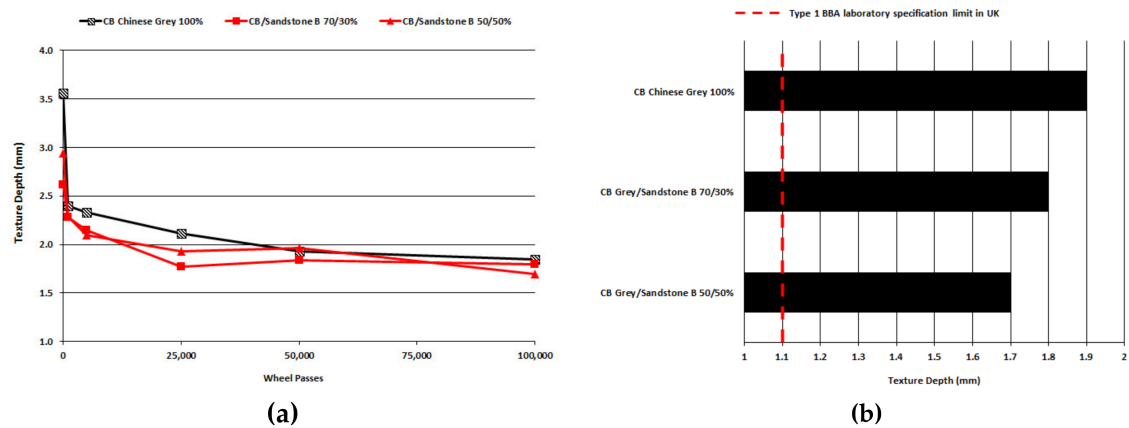
Figure 8. (a) Texture depth development up to 100,000 wheel-passes; (b) texture depth ranking after 100,000 wheel-passes (Ulster University data).

Table 5 shows the development of texture depth data for all the slab specimens up to 100,000 wheel-passes. Figure 8a plots the data for the specimens made using Chinese grey calcined bauxite and sandstone B up to 100,000 wheel-passes. Texture depth values prior to simulated trafficking ranged from 2.6 mm to 3.6 mm. After 1000 wheel-passes all of the specimens had lost texture before entering a slower downward trend for the remainder of simulated trafficking. This was due to removal of some excess aggregate particles in the early stages of simulated trafficking that resulted in the higher volumetric based texture depth measurements obtained.

Figure 8b plots the data for the specimens after 100,000 wheel-passes of simulated trafficking. The best performer was the specimen containing 100% Chinese grey calcined bauxite followed by the specimen containing a blend of 70% calcined bauxite and 30% sandstone. The worst performer was the specimen containing a blend of 50% calcined bauxite and 50% sandstone. Included in Figure 8b is a dotted line running vertically at 1.1 mm texture depth. This is the UK BBA specification limit for Type 1 laboratory specimens tested after 100,000 wheel-passes. This shows that all the specimens would pass the BBA test requirements for Type 1 texture depth after 100,000 wheel-passes.

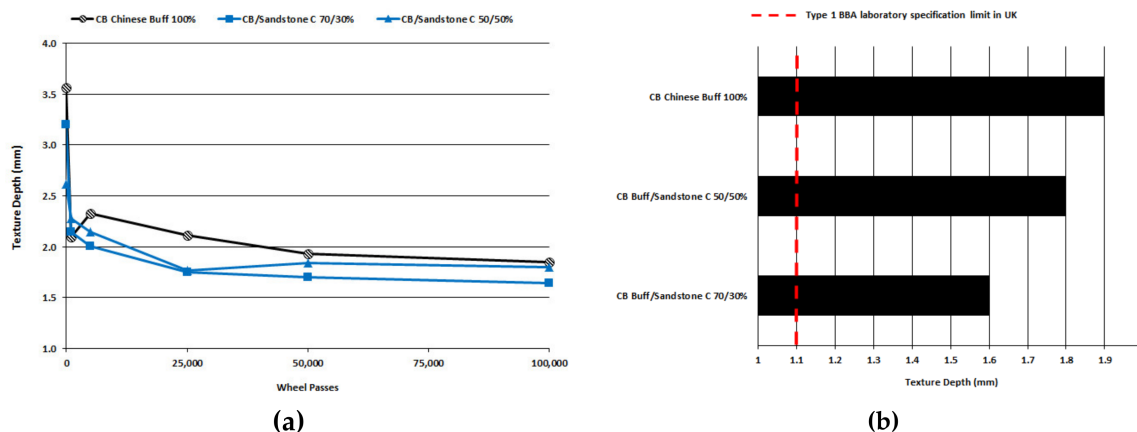
Figure 9. (a) Texture depth development up to 100,000 wheel-passes; (b) texture depth ranking after 100,000 wheel-passes (Ulster University data).

Figure 9a plots the data for the specimens made using Chinese buff calcined bauxite and sandstone C up to 100,000 wheel-passes. Texture depth values prior to simulated trafficking ranged from 2.6 mm to 3.6 mm. After 1000 wheel-passes all of the specimens had decreased sharply before entering a slower downward trend for the remainder of simulated trafficking.

Figure 9b plots the data for the specimens after 100,000 wheel-passes of simulated trafficking. The best performer was the specimen containing 100% Chinese buff calcined bauxite followed by the specimen containing a blend of 50% calcined bauxite and 50% sandstone. The worst performer was the specimen containing a blend of 70% calcined bauxite and 30% sandstone. Included in Figure 9b is a red dotted line running vertically at 1.1 mm texture depth. This is the BBA specification limit for Type 1 laboratory specimens tested after 100,000 wheel-passes. This shows that all the specimens would pass the BBA test requirements for Type 1 texture depth after 100,000 wheel-passes.

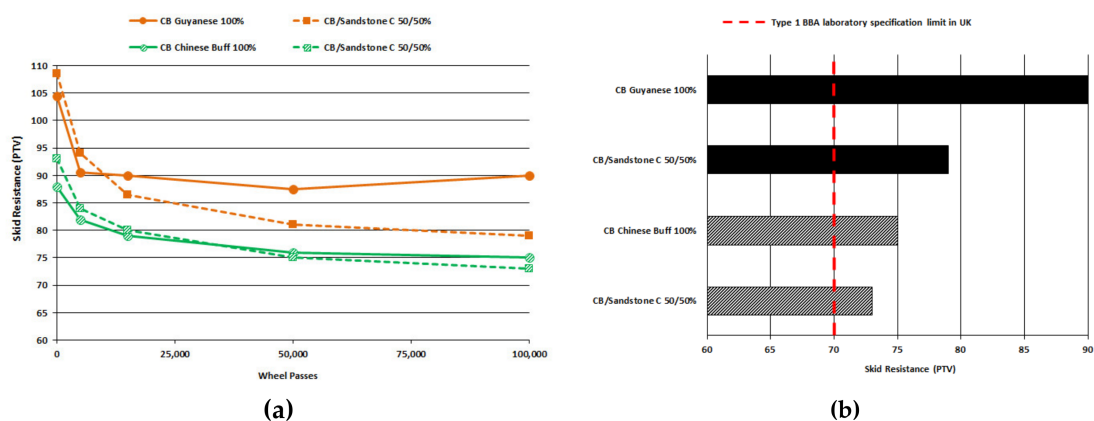
Figure 10. (a) Skid resistance development up to 100,000 wheel-passes; (b) skid resistance ranking after 100,000 wheel-passes (Ulster University data).

Table 6 shows the development of skid resistance data for all the slab specimens up to 100,000 wheel-passes. Figure 10a plots the data for the specimens made using Guyanese and Chinese buff calcined bauxite and sandstone C. Prior to and during simulated trafficking there was a clear difference between the specimens containing Guyanese calcined bauxite and Chinese buff calcined bauxite. The Guyanese calcined bauxite outperformed the Chinese buff calcined bauxite.

Figure 10b plots the data for the specimens after 100,000 wheel-passes of simulated trafficking. The specimen containing 100% Guyanese bauxite had a PTV of 90. Replacing 50% of the Guyanese calcined bauxite with 50% of sandstone C gave a PTV of 79. The specimen containing 100% Chinese buff calcined bauxite had a PTV of 75. Replacing 50% of the Chinese buff calcined bauxite with 50% of sandstone C gave a PTV of 73. Included in Figure 10b is a dotted line running vertically at 70 PTV. This is the BBA specification limit in the UK for Type 1 laboratory specimens tested after 100,000 wheel-passes. This shows that all the specimens would pass the BBA test requirements for Type 1 skid resistance after 100,000 wheel-passes.

In experiment 3, Figure 10a shows both sets of specimens to have a similar trend of friction development with equilibrium being reached after 50,000 wheel-passes. Figure 10b shows the Guyanese calcined bauxite to be superior in performance to all the other specimens including the Chinese buff calcined bauxite. The specimen containing 50% Guyanese calcined bauxite and 50% sandstone C had a skid resistance four points higher than the 100% Chinese buff calcined bauxite. This illustrates potentially significant cost savings whilst ensuring performance. Figure 11a shows texture development to be similar for both sets of specimens during testing. Figure 11b shows texture depths ranging from 1.8 to 1.6 mm. The experiment shows that all specimens would meet the laboratory wear test specification requirements for Type 1 HFS in the UK.

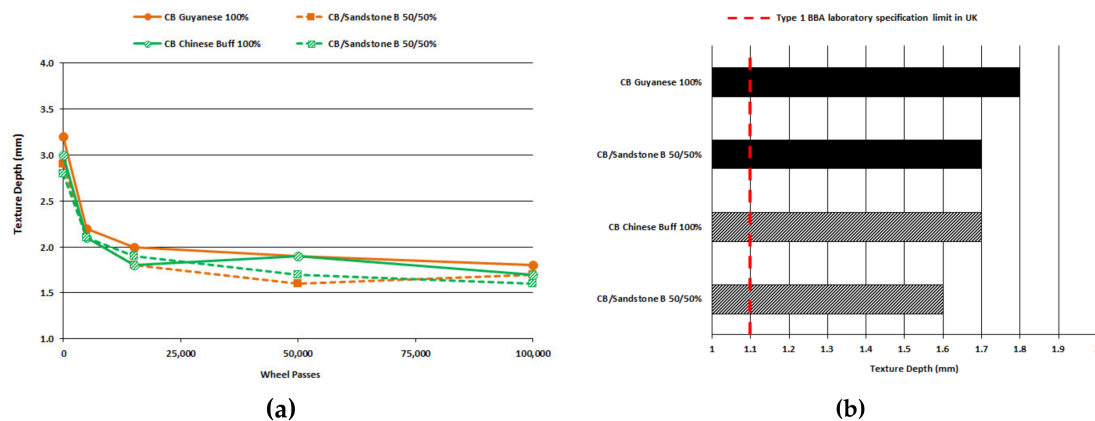
**Figure 11.** (a) Texture depth development up to 100,000 wheel-passes; (b) texture depth ranking after 100,000 wheel-passes (Ulster University data).

Table 7 shows the development of texture depth data for all the slab specimens up to 100,000 wheel-passes. Figure 11a plots the data for all the specimens that were made using Guyanese and Chinese buff calcined bauxite and sandstone C. Texture depth values prior to simulated trafficking ranged from 2.7 to 3.0 mm. After 5000 wheel-passes all the specimens had decreased sharply before entering a slower downward trend for the remainder of simulated trafficking.

Figure 11b plots the data for the specimens after 100,000 wheel-passes of simulated trafficking. The best performer was the specimen containing 100% Guyanese calcined bauxite. The worst performer was the specimen containing a blend of 50% Chinese buff calcined bauxite and 50% sandstone C. The specimen containing a blend of 50% Guyanese calcined bauxite and 50% sandstone C had the same texture depth as the specimen containing 100% Chinese buff calcined bauxite. Included in Figure 11b is a dotted line running vertically at 1.1 mm texture depth. This is the BBA specification limit for Type 1 laboratory specimens tested after 100,000 wheel-passes. This shows that all the specimens would pass the BBA test requirements for Type 1 texture depth after 100,000 wheel-passes.
